FACILITY CONDITION ASSESSMENT

Central Warehouse | February 2022

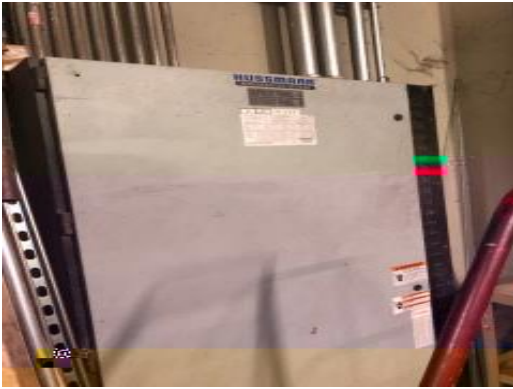
Hassmann panel inaccessible

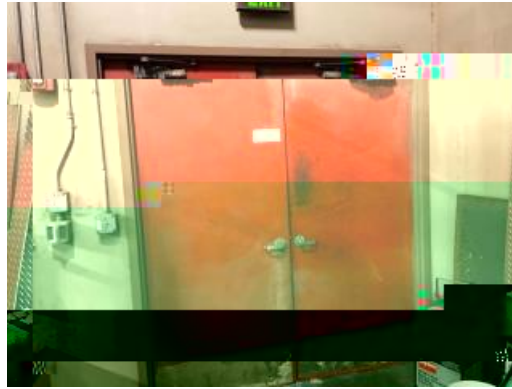
Steel doors are beyond their useful life

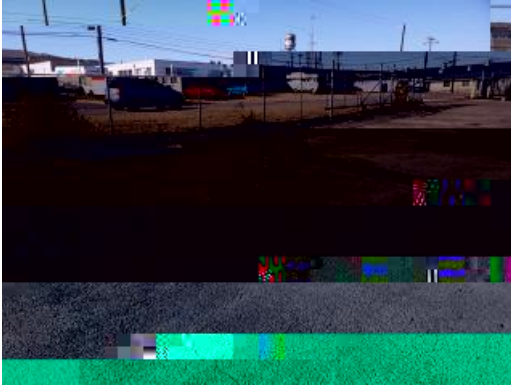
Asphalt pavement at end of life
