FACILITY CONDITION ASSESS

Coy Facility | February 2022

Coy Facility is located at 4900 Gonzales St in Austin, Texas. The oldest building is 63 years old (at time of 2020 assessment). It comprises 112,679 gross square feet.

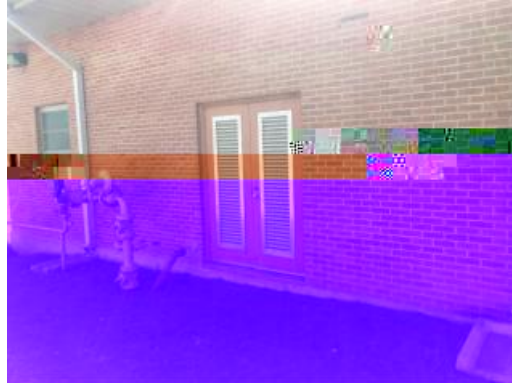
Exterior door deficiency

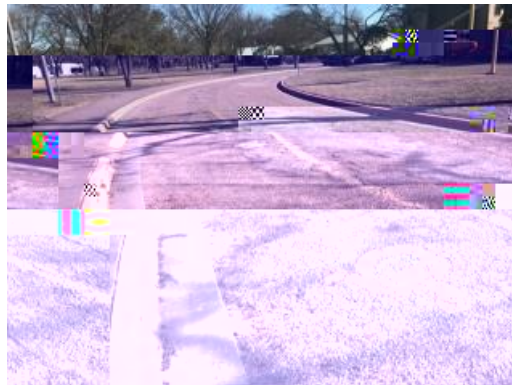
Asphalt drive past useful life

| Deficiency | Category | Qty | UoM | Priority | Repair Cost | ID |
|---|---|---|---|---|---|---|
| Asphalt Driveway Replacement | Capital Renewal | 9,200 | SF | 3 | \$59,160 | 4168 |
