FACILITY CONDITION ASSESSMENT

Langford ES | February 2022

Austin ISD - Langford

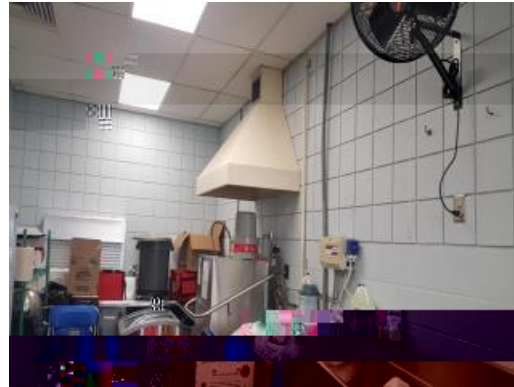
Deficient interior lighting
