FACILITY CONDITION ASSESS

Oak Springs ES | February 2022

Austin ISD - Oak Springs

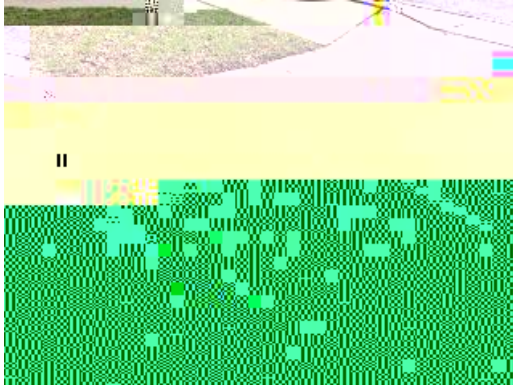
Damaged sidewalk
