Executive Summary

Overton ES is located at 7201 Colony Loop Dr in Austin, Texas. The oldest building is 13 years old (at time of assessment). It comprises 83,405 gross square feet.

Facility Condition Assessment

Austin ISD - Overton

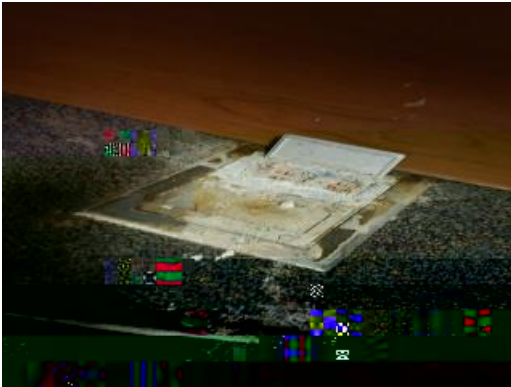
Corroded floor electrical box

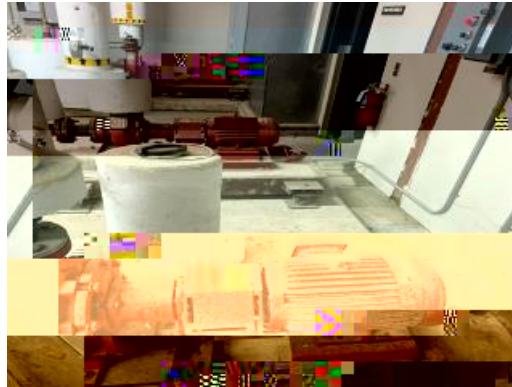
Corroding pumps

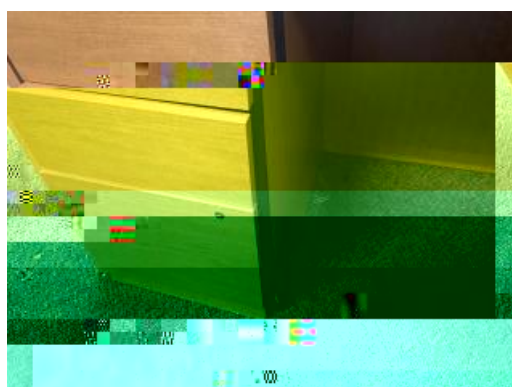
Chipped wood drawers
