# FACILITY CONDITION ASSESS

Ridgetop ES | February 2022

# Facility Condition Assessment

Austin ISD - Ridgetop

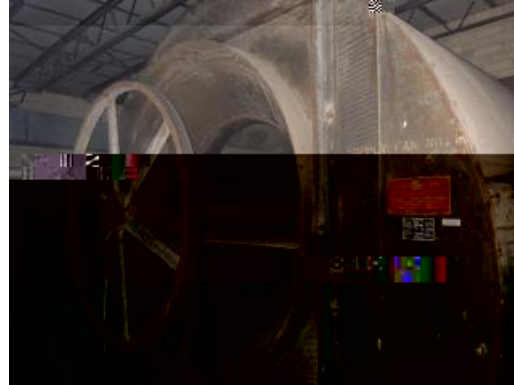
Aged and rusted supply fan

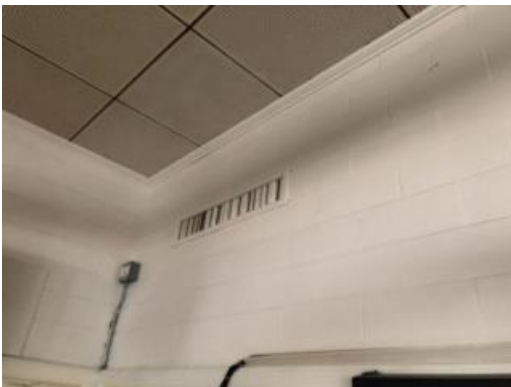
Painted glazed structural tile

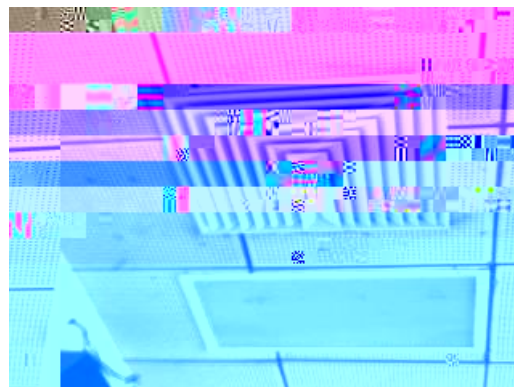
Damaged ceiling tiles
