# FACILITY CONDITION ASSESSMENT

Saegert Bus Terminal | February 2022

Austin ISD - Saegert Bus Term

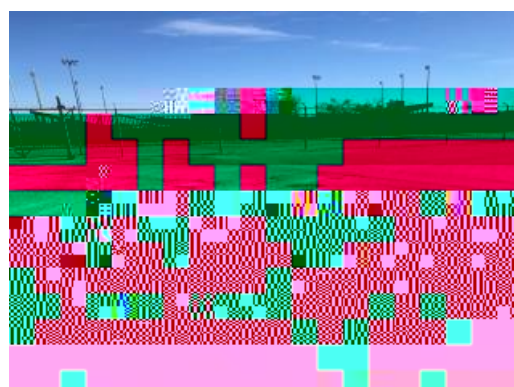
Deficiency	Category	Qty	UoM	Priority	Repair Cost	ID
Asphalt Driveway Replacement	Capital Renewal	18,165	SF	3	\$116,809	778
Note: potholes, rutting, and cracking throughout site						
Location: primarily in northeast and northwest parking lots						
Fencing Replacement (8' - 10' high Chain Link Fence)	Capital Renewal	50	LF	4	\$3,917	777
Note: damaged fencing						
Location: northeast corner of site						
Paving Restriping	Deferred Maintenance	50	CAR	5	\$1,663	779
Note: pavement striping is fading						
Location: primarily NE and SW parking lots						
PROGRAM DEFICIENCIES	ADA Compliance	748,760	EACH	5	\$4,185,471	4385
PUBLIC DEFICIENCIES	ADA Compliance	32,318	EACH	5	\$55,489	4384
Site Signage Replacement	Capital Renewal	1	Ea.	5	\$241	780
Wheel Stop Replacement	Deferred Maintenance	4	Ea.	5	\$694	781
Note: four damaged wheel stops						
Location: all three (3) parking areas						
	Sub Total for System	7	items		\$4,364,284

Potholes
