FACILITY CONDITION ASSES

Burger Athletic Complex | February 2022

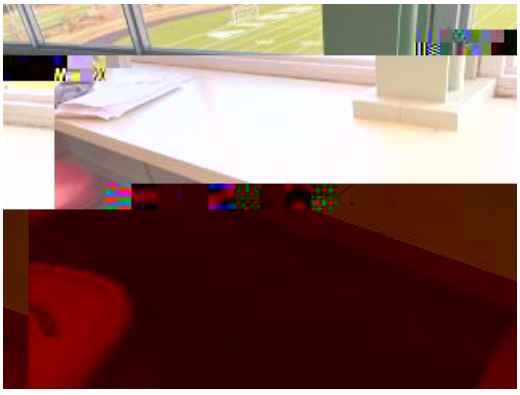
Aged vinyl composition tile flooring
